# ROTTEN to the Core

What started out as a leaky window replacement snowballed into replacing a big chunk of wall

BY TRAVIS BRUNGARDT

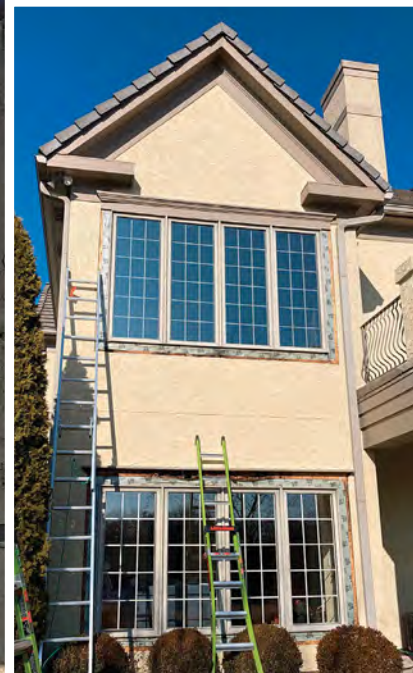
## LOOKS CAN BE DECEIVING

A home's exterior may appear to be just fine, but things are not always as they seem. This stucco-clad home built in the early 2000s looked good from the outside, but leaking, poorly flashed windows and a missing water-resistive barrier had turned the sheathing to compost on the south-facing elevation.

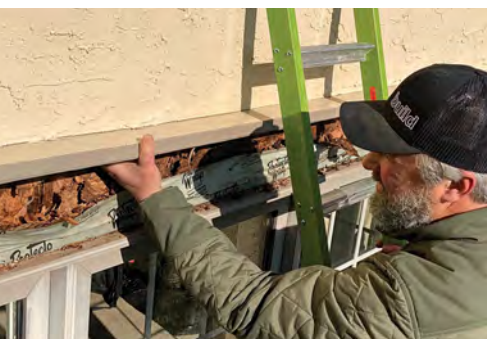
## MORE THAN A NEW WINDOW

Once we removed the trim, we found that the damage was worse than we expected. The original builders tried to seal the windows from water intrusion by taping over the nailing flange with flashing tape, but it did little to prevent water from getting into the opening and rotting the sheathing. We pulled off the stucco to get to the rotten sheathing and framing.

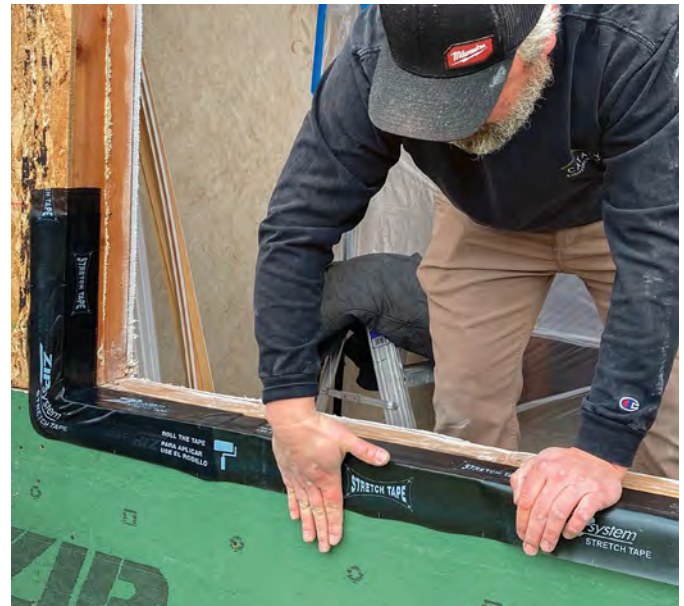
Poor window flashing details contributed to this wall’s sorry condition. We used Zip System stretch tape to create a continuous sill-pan flashing to protect the sheathing and framing.

## PREP THE OPENING

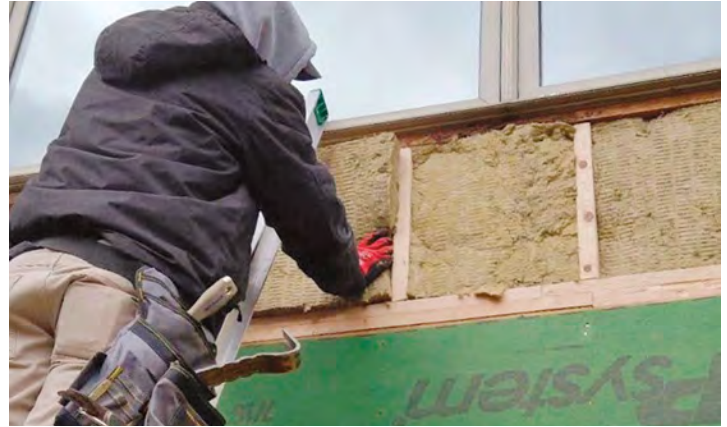
The fiberglass batts under the windows had mold and water damage to the kraft-paper facing, so we replaced them with mineral wool. We like mineral-wool batts because they're more rigid, making it easier to get a tight fit.

## NEW INSULATION
