# ROTTEN to the Core

What started out as a leaky window replacement snowballed into replacing a big chunk of wall

BY TRAVIS BRUNGARDT

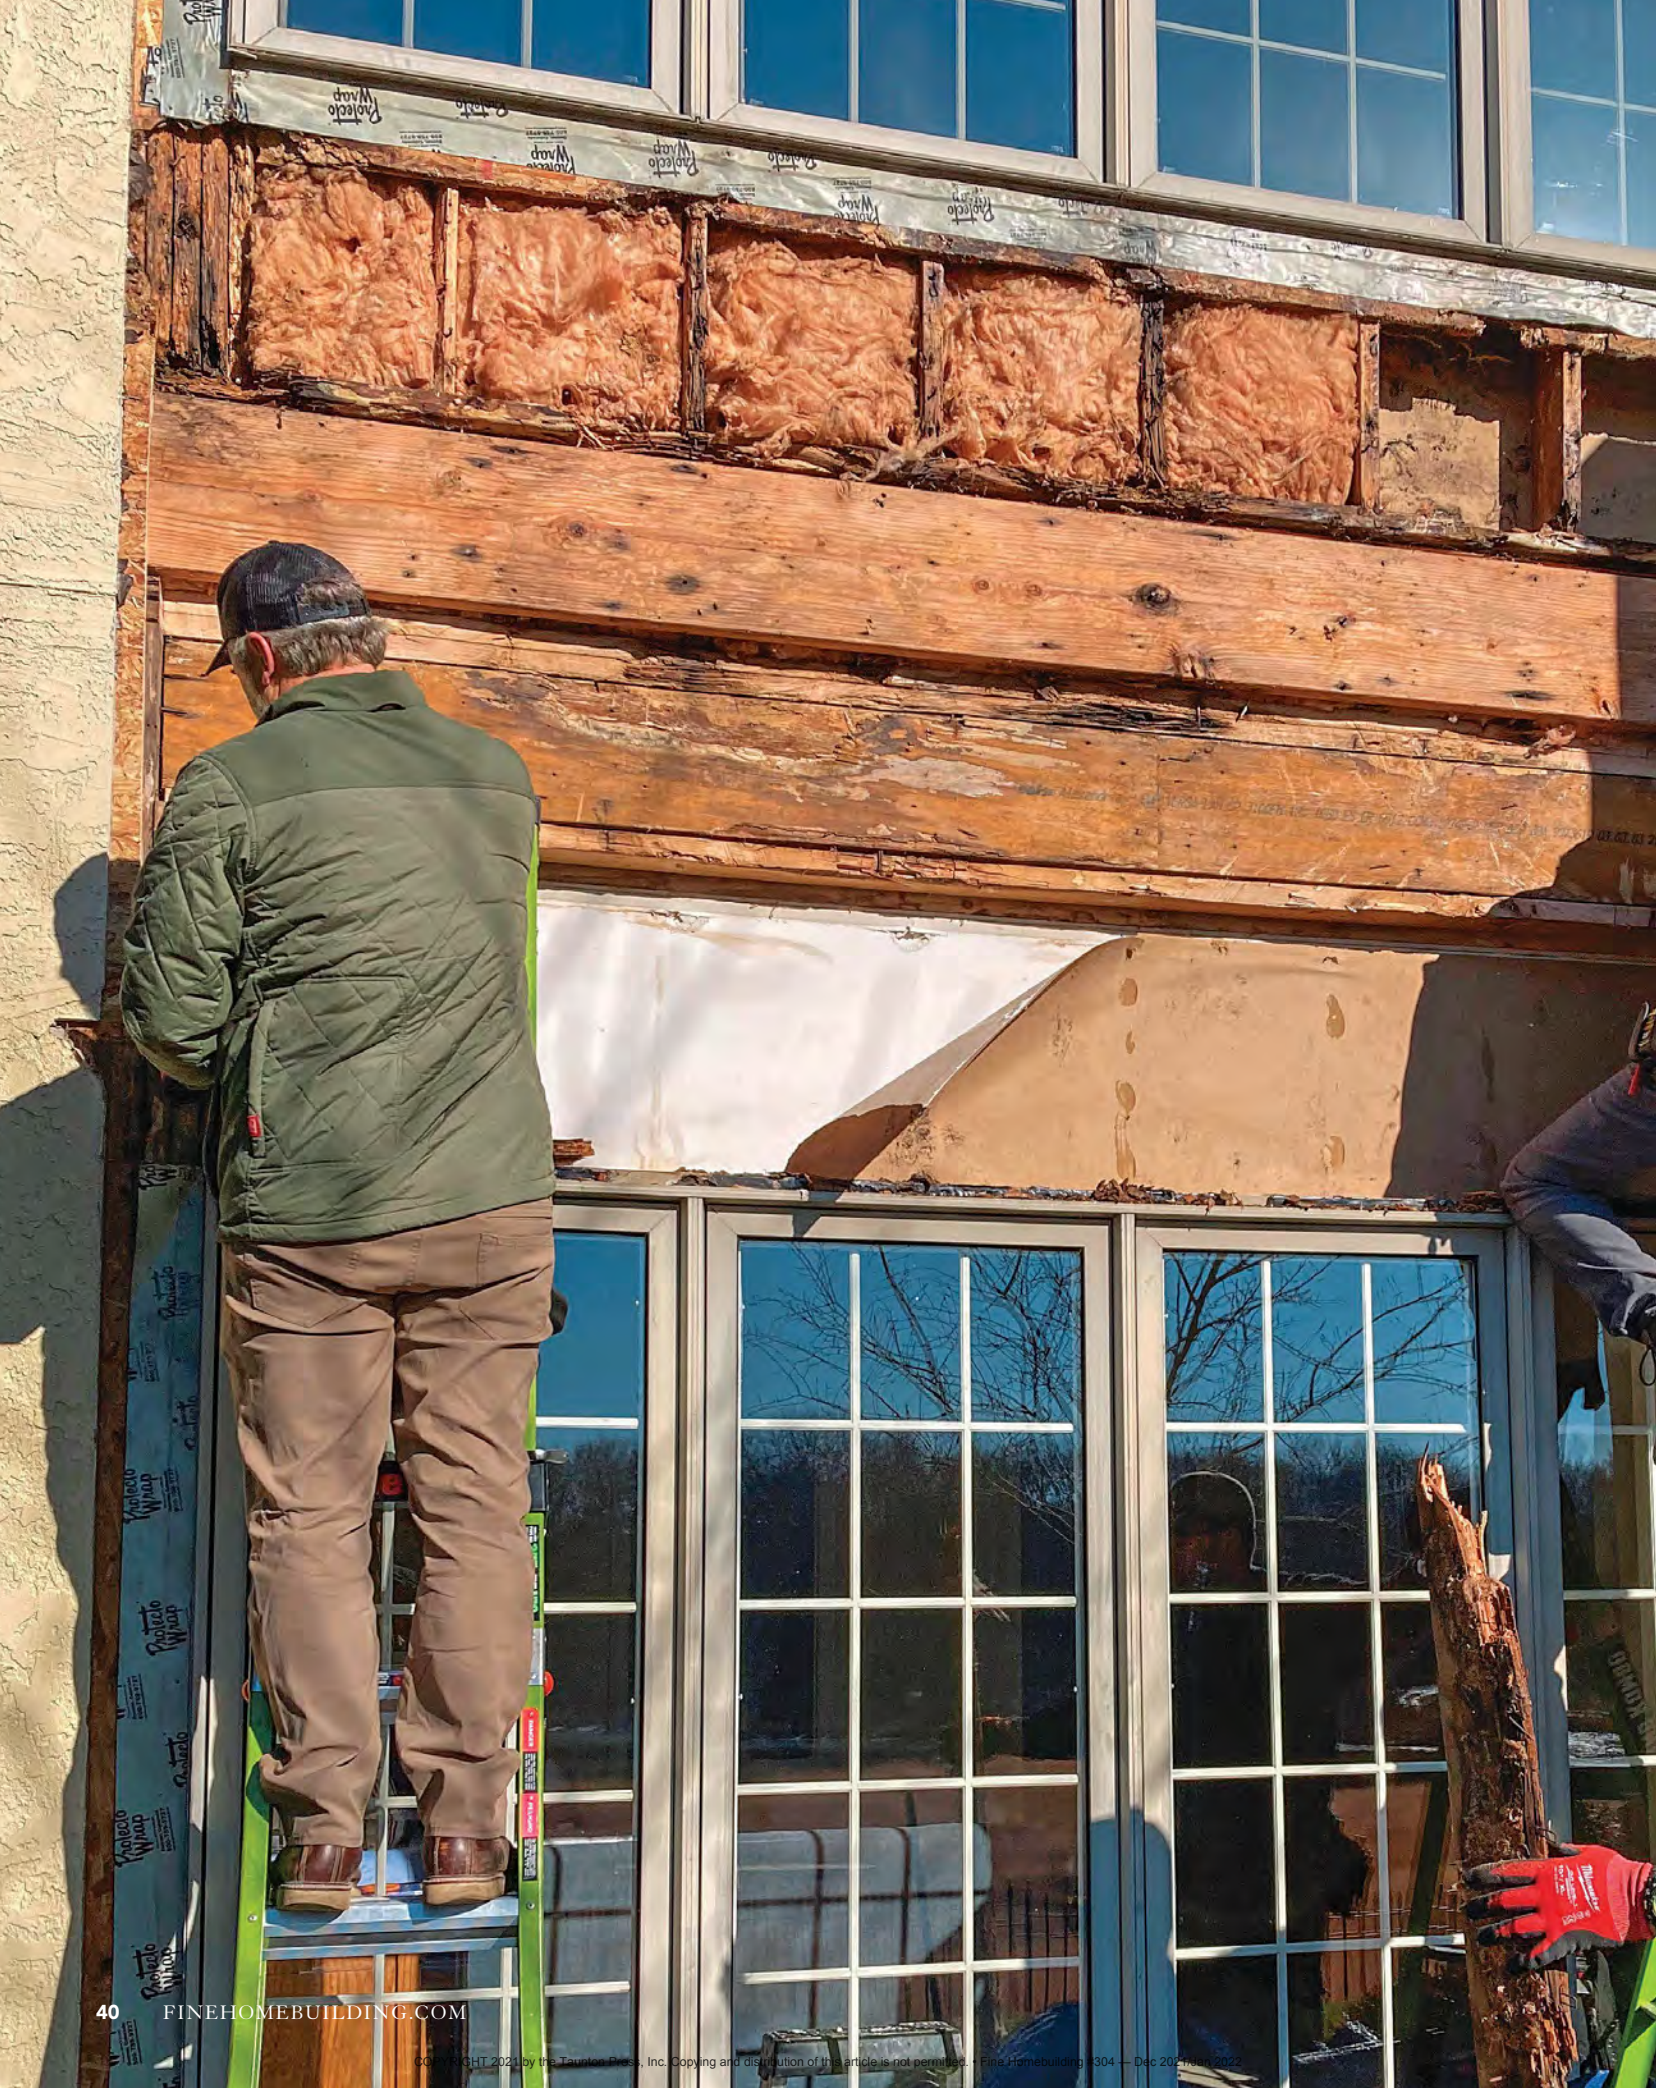
## LOOKS CAN BE DECEIVING

A home's exterior may appear to be just fine, but things are not always as they seem. This stucco-clad home built in the early 2000s looked good from the outside, but leaking, poorly flashed windows and a missing water-resistive barrier had turned the sheathing to compost on the south-facing elevation.
